10/29/21: Facilities Response to Questions from Skyline College Community.

The comparisons between the HVAC system in Skyline's BLDG 5 (Library, Disability/Education Access Resource Center, Learning Center, etc) and Canada's Library seem to indicate very different systems.

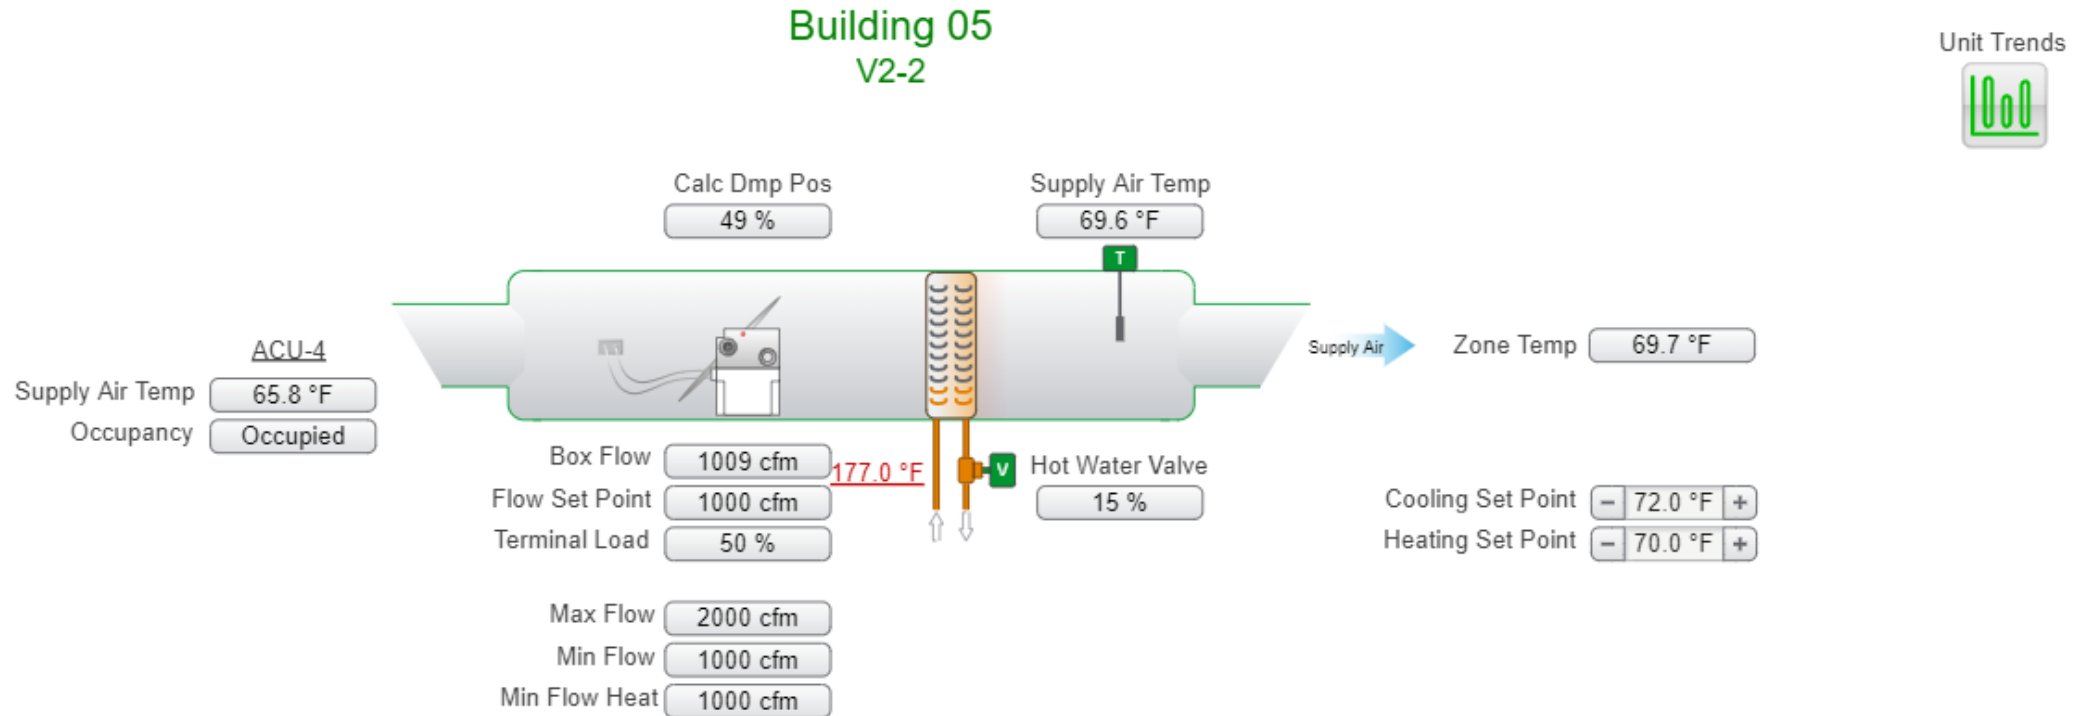
Skyline B5 – Typ. of Variable Air Volume units (VAVs)

VAVs:

- Regulates air flow to each space based on cooling and ventilation demands in the space
- Building automation system continuously monitors the units and generates alarm to facilities team if space temperature goes out of range
- Trending

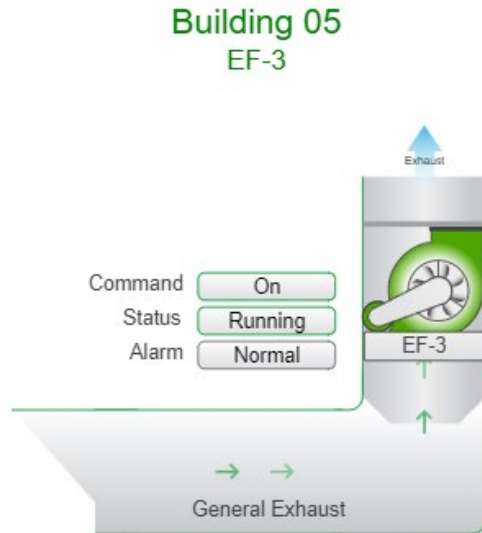
Skyline B5 – Typ. of Exhaust Fans (EFs)

EFs:

- Serves Restroom and Custodial spaces
- Building automation system continuously monitors the units and generates alarm to facilities team if not functioning properly
- Trending

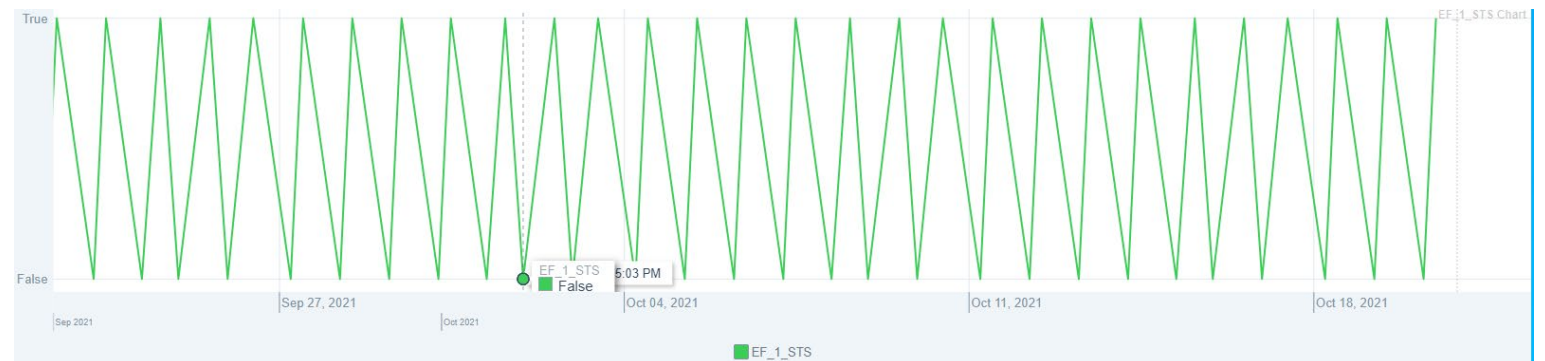
Building 05
Exhaust Fans

Exhaust Fans				
Unit #	Area Served	BM's Command	Status	Alarm
EF-1	---	On	Running	Normal
EF-2	---	On	Running	Normal
EF-3	---	On	Running	Normal

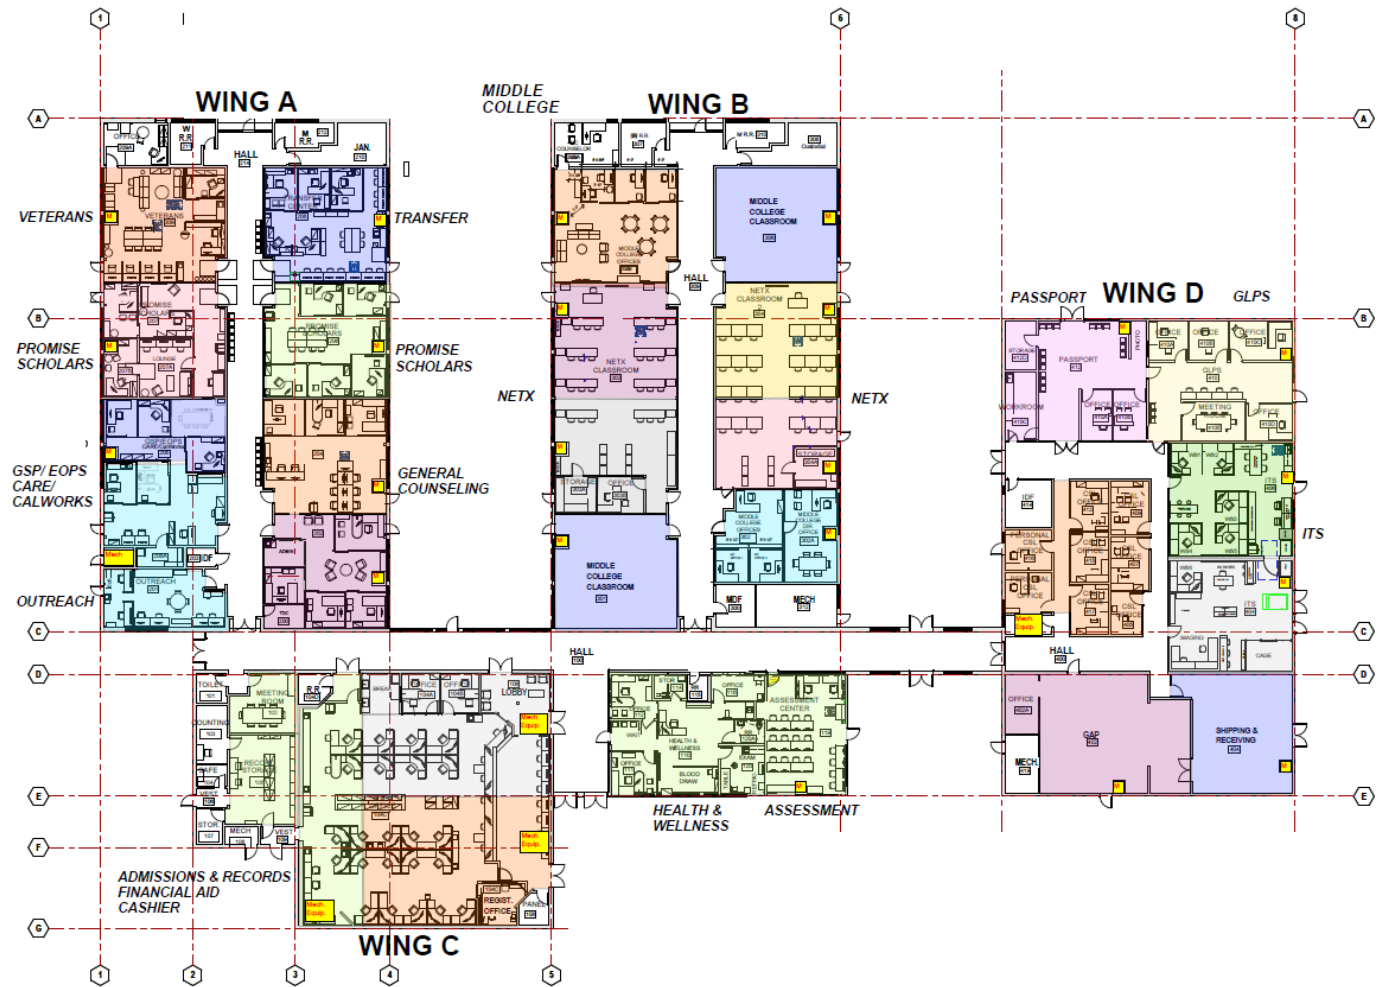
Attachment 3: Graphic shows location of each furnace/exhaust fan unit and the corresponding area it serves in Building 19.
